SUMP DAMAGE

DERIVATIVE: 2.0 Diesel

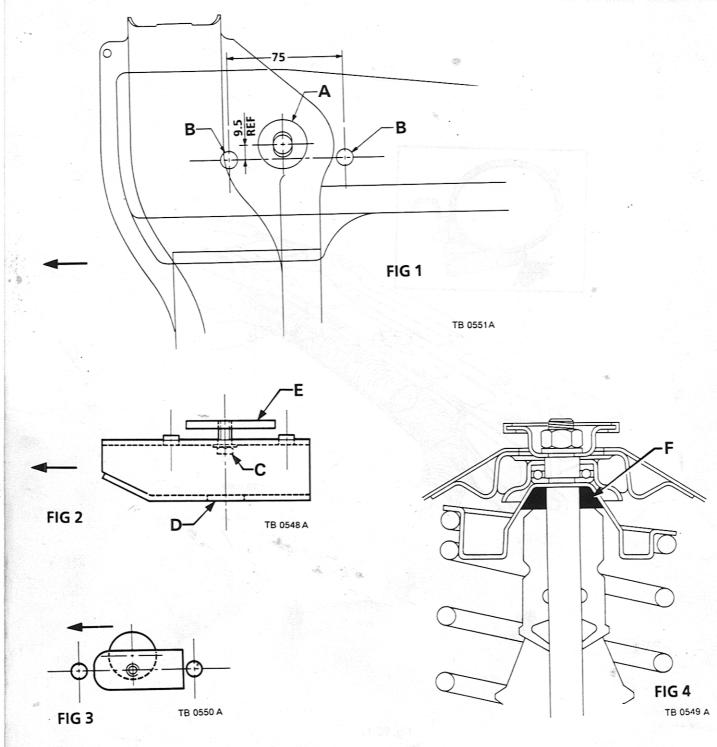
Sump damage

Insufficient ground clearance under abnormal road conditions

- 1 View front subframe from the underside and locate the 2 existing large holes, one either side of the subframe. See 'A' in fig. 1.
- 2 To locate the skids, two smaller 11mm holes on each side of the subframe are also required, one in front of the large hole and one behind. See 'B' in fig. 1. One of these holes already exists on each side and the other must be drilled in position shown in fig. 1.
- 3 Insert screw 'C' through hole in skid plate 'D' and partially into tapped plate 'E' (as fig. 2).
- 4 Slide tapped plate into large hole in underside of subframe.

- 5 Position assembly such that skid plate pegs fit in 11mm locating holes in subframe and plate is in line with centre line of vehicle (as fig. 3).
- 6 Tighten screws to 18-20 Nm.

8 Fit bump stop packer 'F' to both struts as shown in fig. 4
