AUSTIN ROVER

BULLETIN
MONTEGO TECHNICAL

Item 49

TURBOCHARGER PROBLEMS - INCORRECT DIAGNOSIS

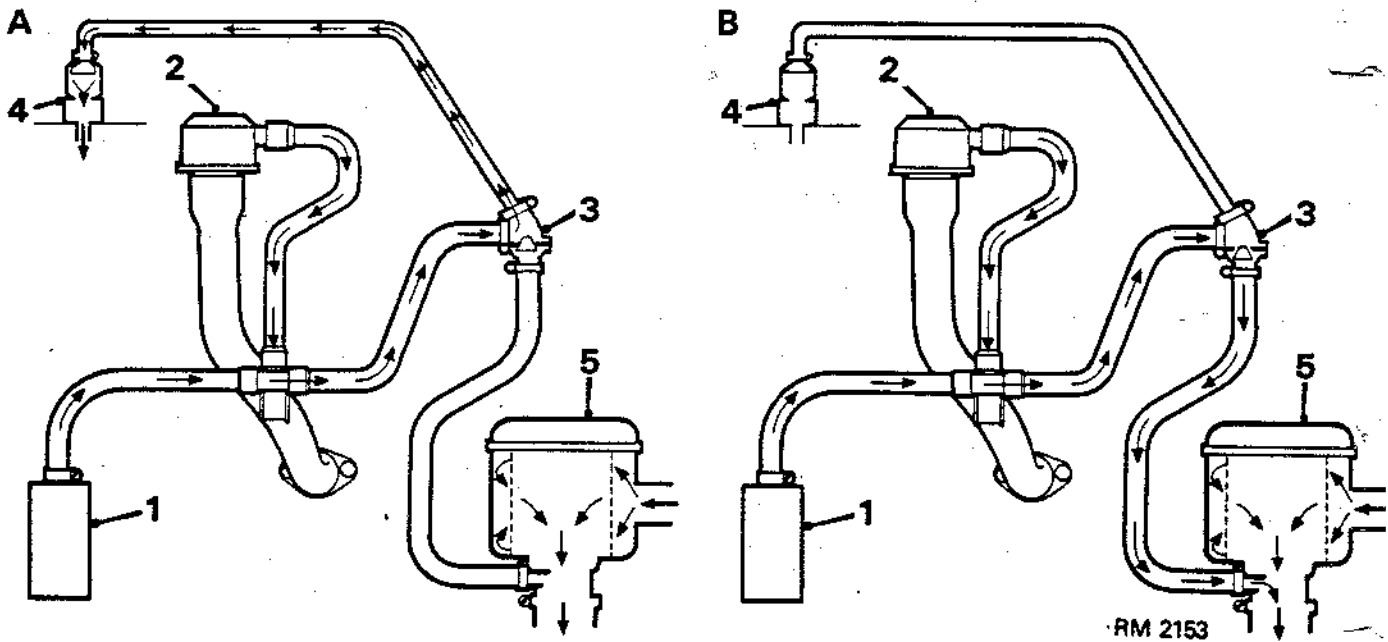
fig. 49/1

Oil mist drawn through breather and intercooler circuit.

Oil may be drawn through the breathing system (and in turn passed through the intercooler circuit) under certain crankcase pressure conditions.

- a. Advise customer that sump should not be filled beyond the maximum mark.
- b. Check that correct dipstick (yellow top, part number UAM 2580) is fitted.
- c. Ensure that breathing system and valves are correctly assembled - refer to fig. 1.

Ensure that breather restrictor has been fitted in correct position in one-way valve - see section 2.

- d. Remove breather pipe from separator and look for evidence of emulsification. If present, remove and flush out all pipes and the plastics regulator valve, replacing any if in doubt. When refitting, ensure that orientation of pipe to diverter valve is correct (fig. 1), clean out oil filler tube and renew oil filler cap and separator. Renew air cleaner element, if oil contaminated.

The primary causes of emulsification are kinked or trapped breather pipes or conditions of use of the car (e.g. frequent cold starting).

If cause of problem cannot be determined by the above action, renew regulator valve (3) and one-way valve (4) - see fig. 1, as neither can easily be checked for correct operation.

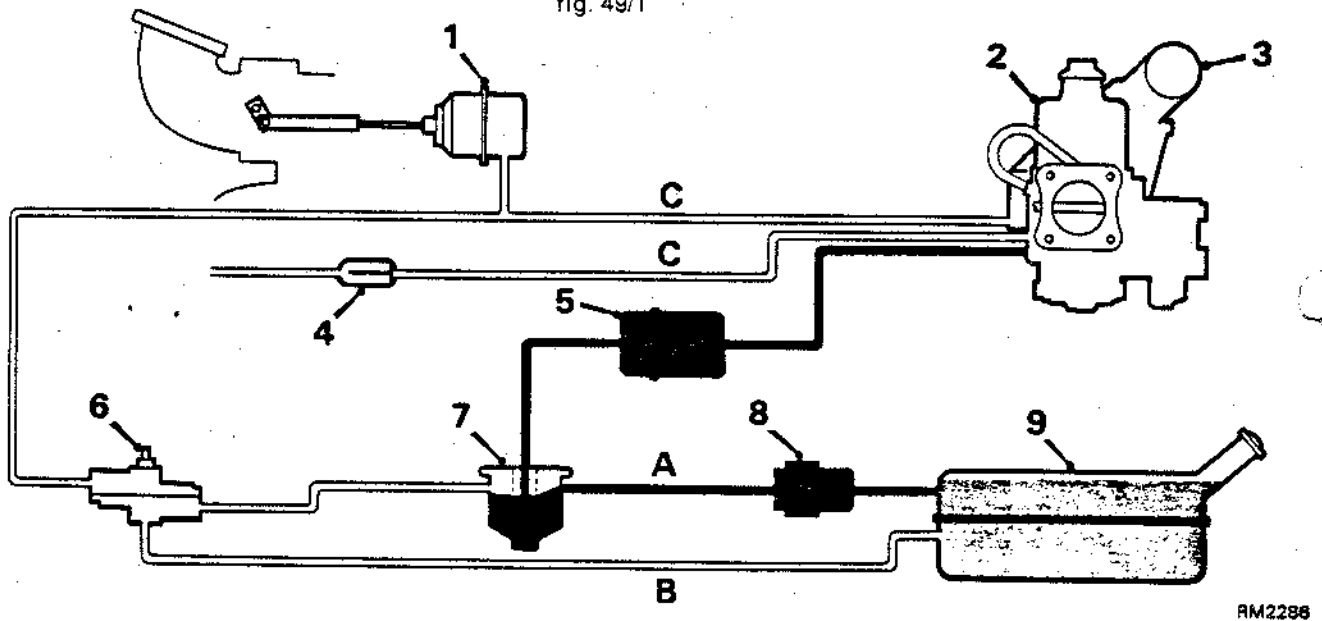
fig. 49/2

Reduced power or late or reduced boost (refer to fig. 2 for layout of fuel and boost sensing hoses):

Disconnect pressure sensing hose from plenum

chamber. Connect a suitable "T" piece, a length of hose and pressure gauge 18G 1500 so that gauge can be positioned inside car.
