AUSTIN ROVER

BULLETIN
Maestro **TECHNICAL**

THROTTLE CABLE SEIZURE

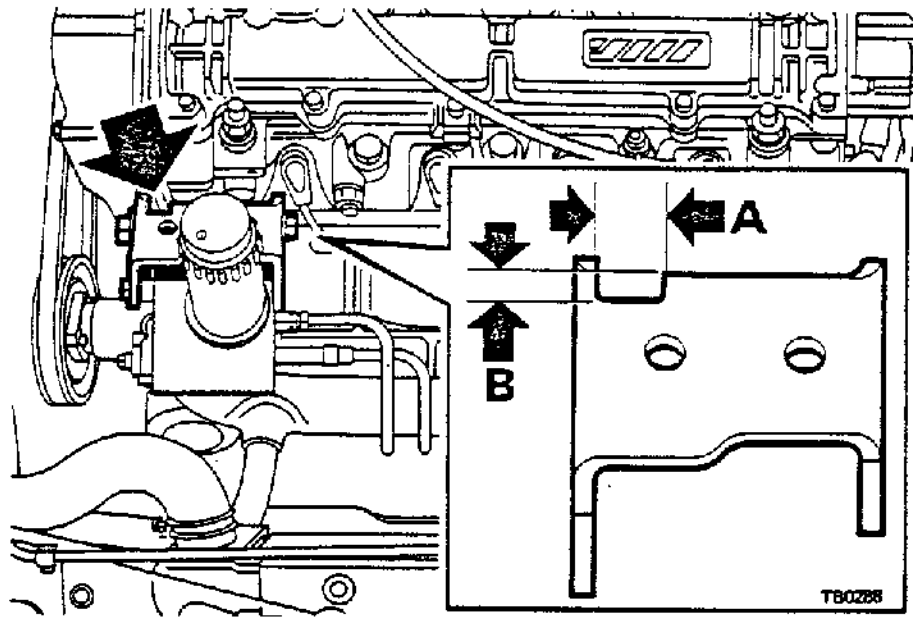
Fig. 3/1

p.a.s. pump belt cannot be adjusted correctly.

p.a.s. bracket fouls cam belt cover bracket when at limit of adjustment

Modified bracket introduced on production at vin 486707 (Maestro) and 379553 (Montego).

On earlier vehicles in service, the bracket can be modified by cutting a recess to the dimensions shown in the illustration.

Dimension "A" = 25 mm

Dimension "B" = 8 mm

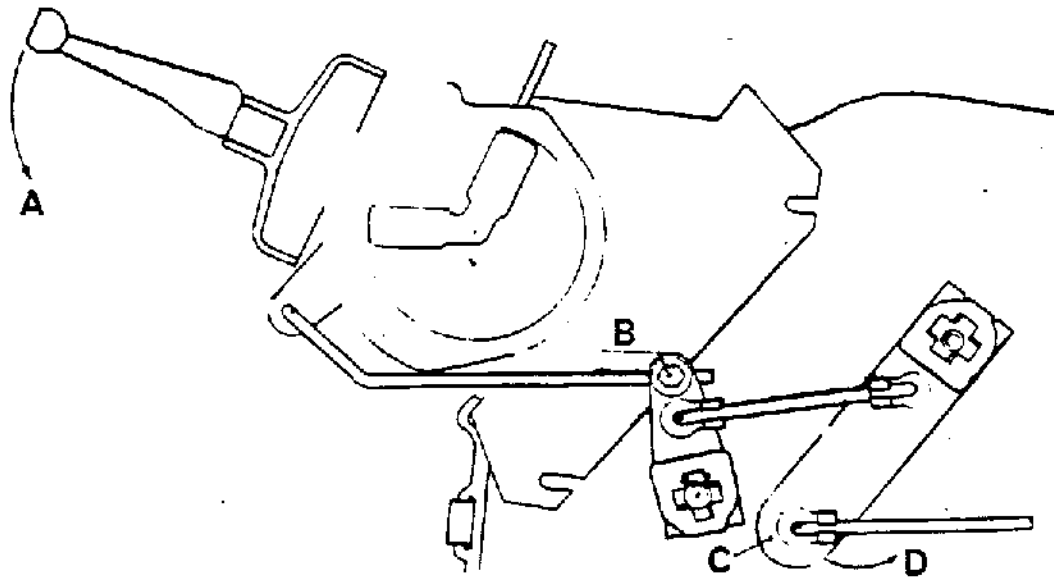
Fig. 4/1

Heater output inadequate

Incorrect adjustment of controls

- 1 Remove fuse panel beneath steering wheel.
- 2 Move heater "blend" control lever 'A' on fascia to maximum heat position.
- 3 Loosen bolt 'B'.
- 4 With blend control lever as far downward as it will naturally travel, rotate lever 'C' in direction of arrow 'D' as far as it will naturally travel.
- 5 With levers 'A' and 'C' held in these positions, re-tighten bolt 'B'.
- 6 Check that blend lever 'A' now stays in the maximum heat detent position.

Move blend lever up and down a few times and then return it to the maximum heat position. If the lever now engages in the maximum heat detent position, the increased effort required to disengage it should be detectable.

- 7 Close all centre vents, set distribution control to "defrost". Select maximum fan speed and check that blend lever remains in maximum heat position. If not, switch fan off and repeat procedure from step 2.
- 8 Replace fuse panel.
- 9 Confirm that heater performance is now satisfactory.
