AUSTIN ROVER

BULLETIN
MAESTRO TECHNICAL

Item 5

DOOR HINGE WELDS - INCOMPLETE

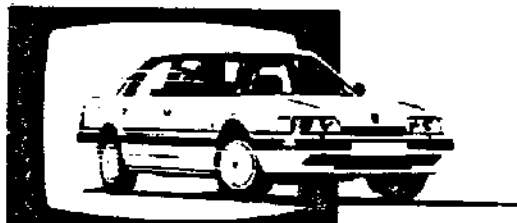
Welds between hinges and doors imperfect or incomplete.

Robot welder not operating correctly.

- 1 Examine welds (arrowed in illustration) between the hinges and the door on all four passenger doors (two doors only on van) and the door. Look for missing welds and for any weld in which the filler metal has not made a proper bond with the door panel.
- 2 Any missing or suspect weld should be dealt with as follows:
 - a. remove trim pad from door and disconnect wiring, where fitted.
 - b. remove door from car.
 - c. ensure that nothing within door will be damaged during welding.
 - d. use mechanical means, e.g. small rotary wire brush,

Examine welds as described below and re-weld as necessary.

to remove paint from area to be welded and make repair as necessary, using CO2 welding.

- e. clean off welded area, degrease and repaint using etch primer and normal repainting process. Treat similarly bare area on body where hinges are bolted and mating faces of hinges.
- f. treat inside of door where hinges are attached with Unipart cavity wax.
- g. refit door to car and adjust as necessary.
- h. make good paint damage to bolt heads.
- i. re-assemble door.
