AUSTIN ROVER

BULLETIN
MAESTRO TECHNICAL

Item 9

COOLANT LEAK FROM RADIATOR
 (Issue 2 to correct part nos.)

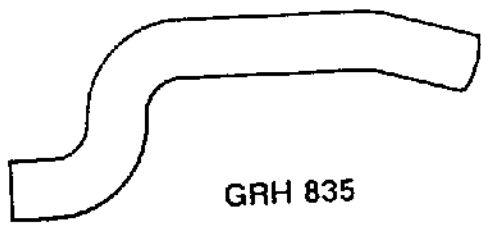
GRH 835

Coolant leaking from radiator.

Radiator damaged by engine vibration transmitted via excessively rigid top hose.

More flexible top hose introduced at vin:

A modified hose can be identified as shown (see illustration) and, where this problem is encountered, one should be fitted at the same time as a replacement radiator to avoid recurrence.

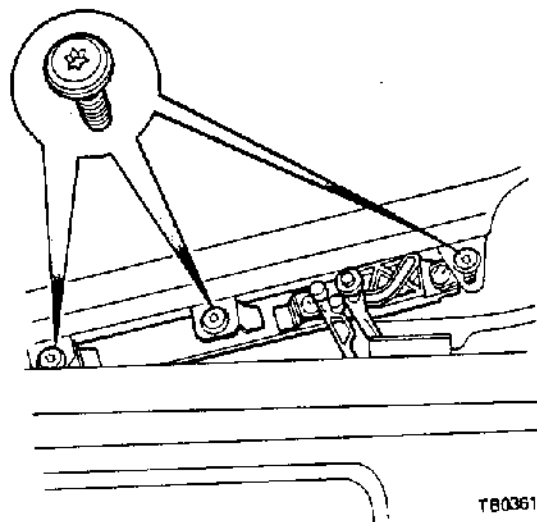
fig. 9/1

Possibility that incorrect fixing screws could be fitted in service

With this change, a different type of culisse fixing screw has also been introduced and UNDER NO CIRCUMSTANCES should the earlier type of screw be used with a plastics culisse - see illustration.

The new screws are recognisable by their being blue in colour as opposed to the black colour of the earlier type

From the VIN below cars with glass panel sun roofs are fitted with plastics culisses.
