**AUSTIN ROVER**

**BULLETIN**  
**MONTEGO TECHNICAL**

**Item 4**

**DOOR HINGE WELDS - INCOMPLETE**

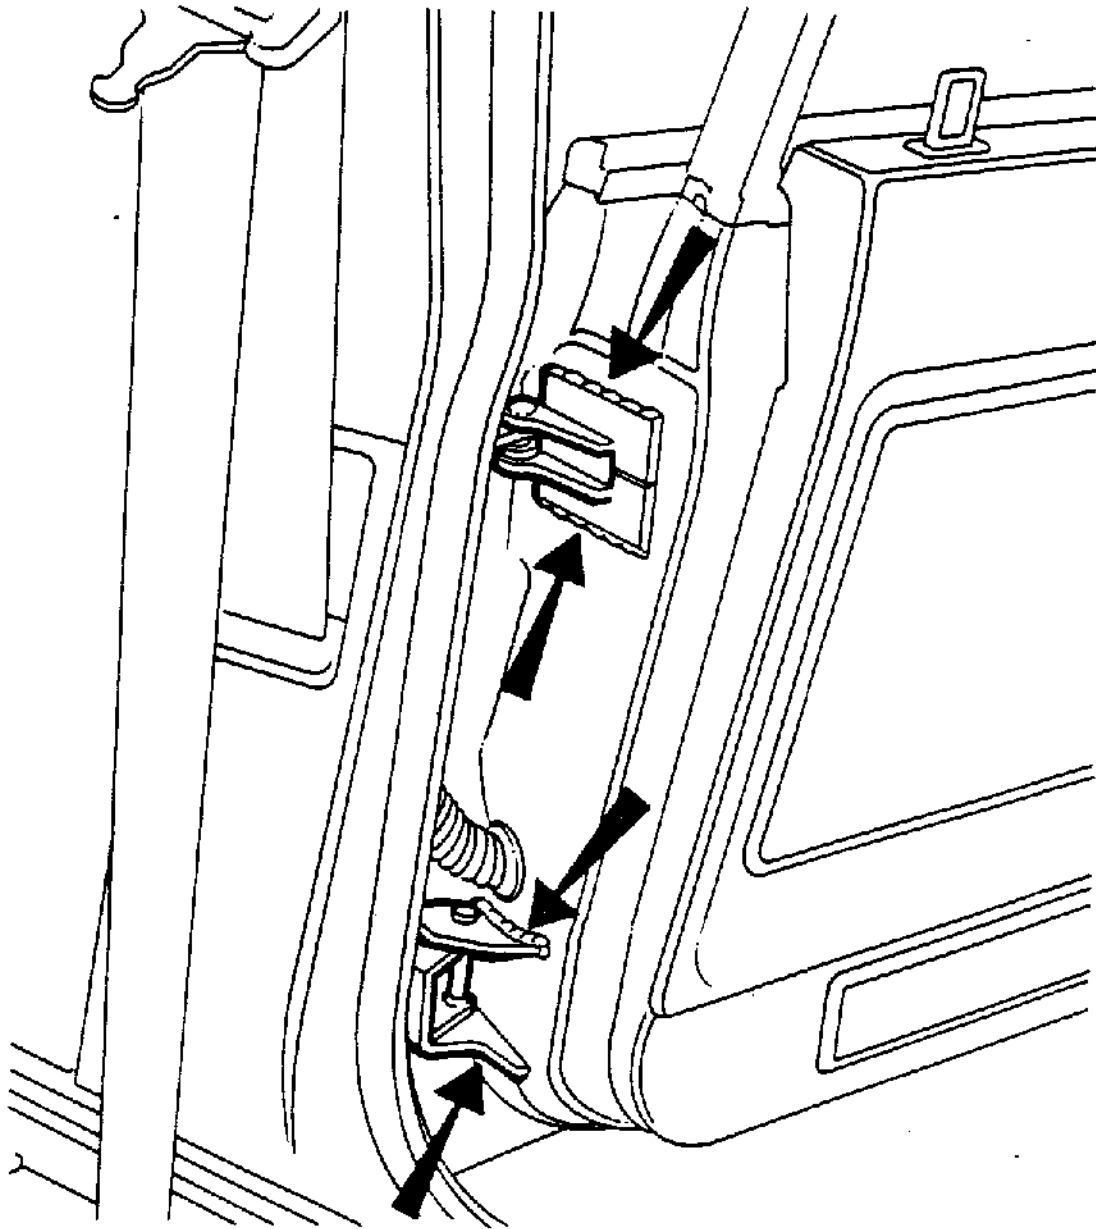
fig. 4/1

Welds between hinges and doors imperfect or incomplete.

Robot welder not operating correctly.

- 1 Examine welds (arrowed in illustration) between the hinges and the door on all four passenger doors (two doors only on van) and the door. Look for missing welds and for any weld in which the filler metal has not made a proper bond with the door panel.
- 2 Any missing or suspect weld should be dealt with as follows:
  - a. remove trim pad from door and disconnect wiring, where fitted.
  - b. remove door from car.
  - c. ensure that nothing within door will be damaged during welding.
  - d. use mechanical means, e.g. small rotary wire brush,

Examine welds as described below and re-weld as necessary.

to remove paint from area to be welded and make repair as necessary, using CO2 welding.

- e. clean off welded area, degrease and repaint using etch primer and normal repainting process. Treat similarly bare area on body where hinges are bolted and mating faces of hinges.
- f. treat inside of door where hinges are attached with Unipart cavity wax.
- g. refit door to car and adjust as necessary.
- h. make good paint damage to bolt heads.
- i. re-assemble door.
