AUSTIN ROVER

BULLETIN
MONTEGO TECHNICAL

Item 10

COOLANT LEAK FROM RADIATOR
 (Issue 2 to correct part nos.)

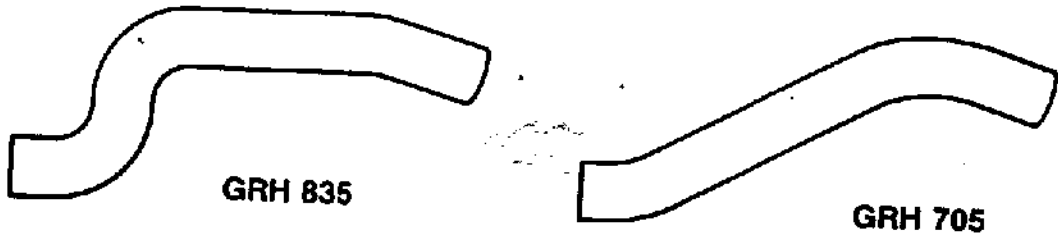
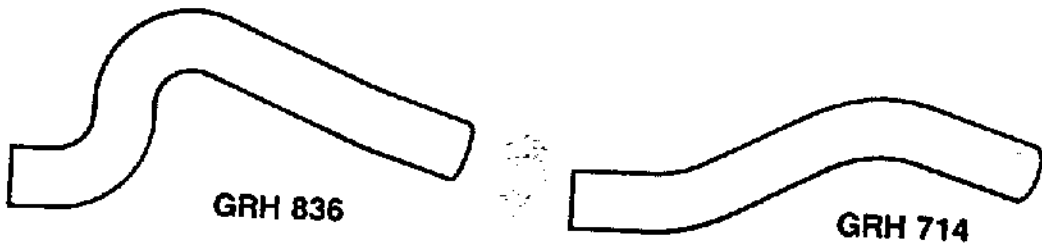
fig. 10/1

Coolant leaking from radiator.

Radiator damaged by engine vibration transmitted via excessively rigid top hose.

A modified hose can be identified as shown (see illustration) and, where this problem is encountered, one should be fitted at the same time as a replacement radiator to avoid recurrence.

More flexible top hose introduced at vin:

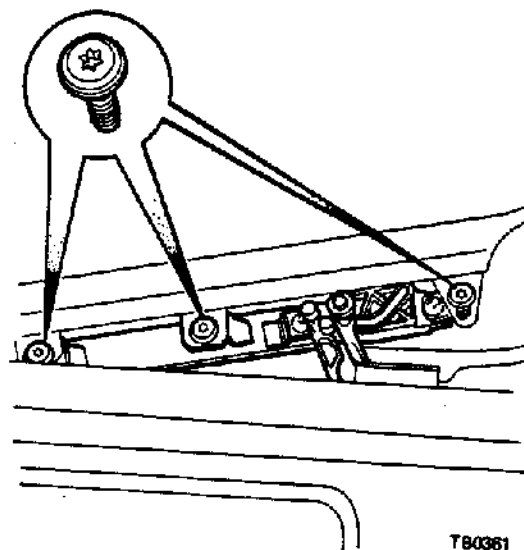
fig. 12/1

Possibility that incorrect fixing screws could be fitted in service.

With this change, a different type of culisse fixing screw has also been introduced and UNDER NO CIRCUMSTANCES should the earlier type of screw be used with a plastics culisse - see illustration.

The new screws are recognisable by their being blue in colour as opposed to the black colour of the earlier type.

From the VIN below, cars with glass panel sun roofs are fitted with plastics culisses.
