**AUSTIN ROVER**

**BULLETIN**  
**MONTEGO** **TECHNICAL**

**Item 26**

**SPOT WELDS VISIBLE ON SIDE DOORS**

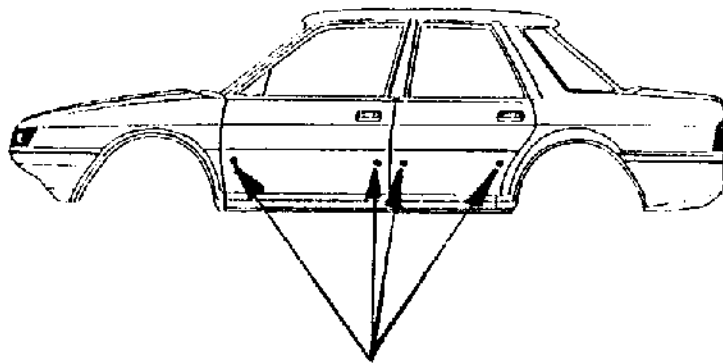
fig. 26/1

Spot welds visible adjacent to front and rear edges of side doors on cars to which rubbing strips (supplied with the car) are to be fitted.

As these welds are directly in line with the fitting position for the strips and are completely covered when these are fitted, it has been deemed unnecessary to undertake any re-working and no claims will be accepted for such re-work.

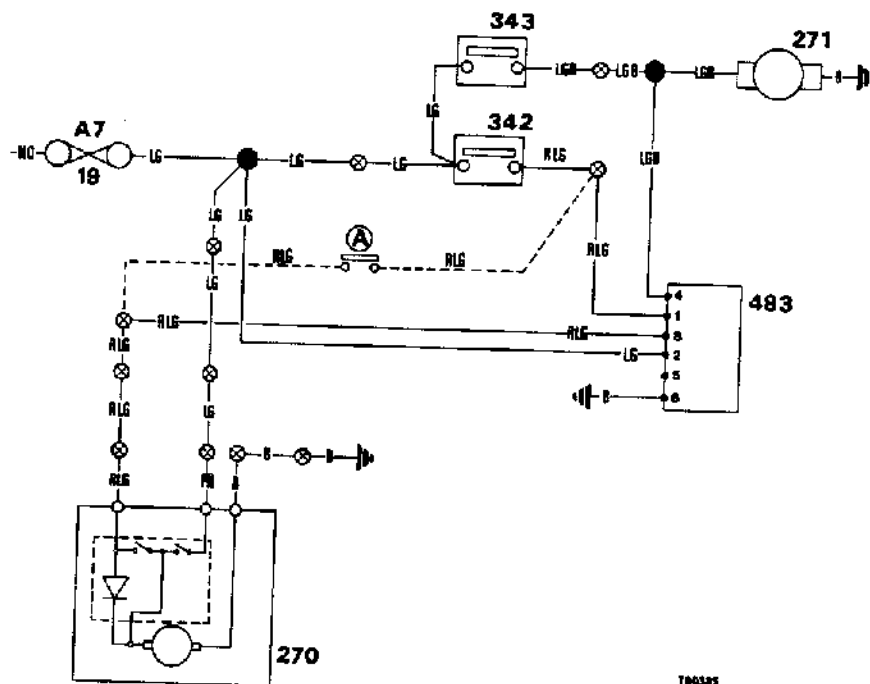
fig. 27 1

Requests for the provision of continuous rear wipe or automatic operation in reverse gear have been received from some customers.

Whilst no specific recommendations are being made it should be noted that this can be provided by installing a simple "on-off" switch to connect together the two red/green leads (pin 1 and pin 8) of the rear wiper programme unit. The connections required are shown as dotted lines at "A" in fig. 1. (Wiring colours and other items are as in the supplementary diagram in the repair manual.)

When the switch is in the "open" position, programmed wipe with delay is provided. When the switch is "closed", continuous wipe will be available whenever the fascia panel rear wiper switch is operated.

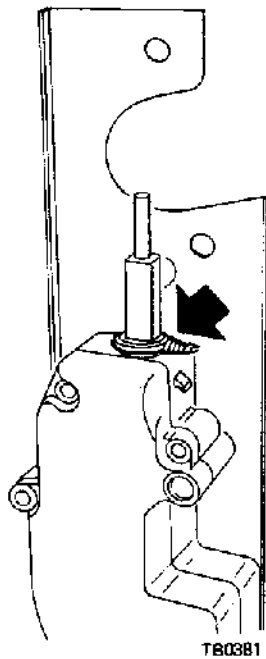
fig 28.1

Central door locking fails to operate on boot or tailgate locks.

Motor driven locking plunger partially withdrawn from lock due to "bounce back", allowing locking mechanism to disengage.

- 1 Remove lock and motor assembly (refer to repair manual).
- 2 Ensure that slots in motor casing through which square nylon plunger carrying locking bolt emerges are free from moulding flash.
- 3 Using suitable soft iron wire, apply one turn in groove of motor casing, twisting wire ends together,

as shown.

- 4 Using flat nosed pliers, continue to twist wire ends together until a slight restriction of plunger movement can be felt.
- 5 Cut off surplus wire, ensuring that any remaining cannot foul any part of mechanism.
- 6 re-assemble lock and motor and test for correct operation.
