70. REAR BRAKE JUDDER

MAESTRO (EXCEPT VAN),  
& MONTEGO

76. FRONT DOOR FOULING  
FRONT WING

ROVER 200

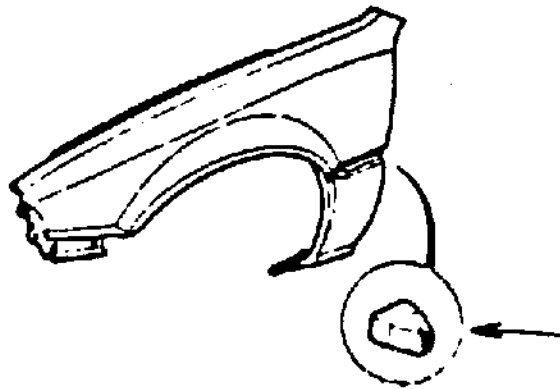
Problem: Excessive flexing of rear edge of front wing  
and/or

Front edge of front door fouls wing.

Action: Check that rubber wedge, wing to 'A' post is correctly positioned. Open front door and examine gap between rear edge of front wing and 'A' post. Rubber wedge should be behind and adjacent to wing finisher strip. If it is adrift or missing, it will be necessary to remove 3 screws at rear lower edge of wheel arch liner to gain access to refit, or fit new, rubber wedge - see diagram.

Part number: DBP 6996 - Stopper, front fender
