AUSTIN ROVER

TECHNICAL

Item 942

76. FRONT SEAT CUSHION COVER DAMAGED

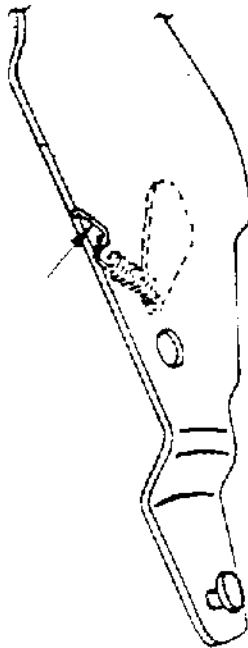
MAESTRO VAN

Instances of the front seat cushion cover being damaged by the squab tipping mechanism have been reported.

1. Remove damaged cushion cover.
2. Fit lock-down catch spring, JPC 8890, in place of existing spring, EAM 6783, to squab pivot plates on both sides, as illustrated.
3. Remove all sharp edges and burrs from squab pivot plates.

4. Fit new cushion cover.
