**AUSTIN ROVER**

**Service****BULLETIN**  
**TECHNICAL**

Item 971

**12. OIL FILTER LEAKING -  
DAMAGED BY STONE-GUARD****MONTEGO 2.0 (AUTO)  
MAESTRO DIESEL VAN****Problem:** Stone-guard fouling engine oil filter, resulting in oil leak.**Action:** Where this problem is evident, the following action should be taken:

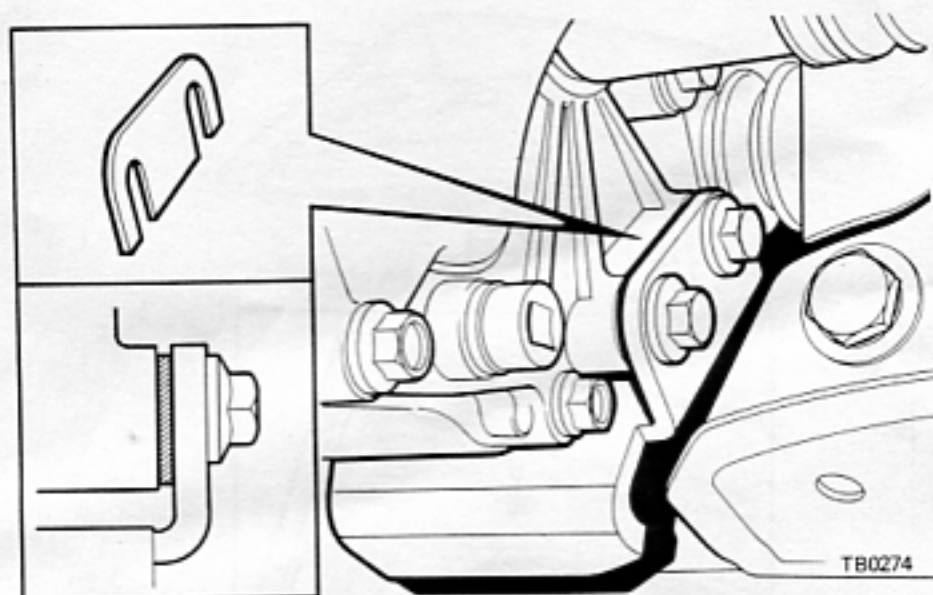
fig. 972/1

Problem: Oil leak at joint, bell housing to gear case.

Cause: Bracket for rear mounting excessively wide and causing joint faces to be pulled apart as bolts are tightened.

Action: Fit shims, part number ADL 2972, between bracket and transmission case so bracket is firm fit over case. Tighten bolts only to 45 N m.

No more than three shims may be used; should this number be insufficient, a new bracket should be fitted (suitably shimmed, if necessary).

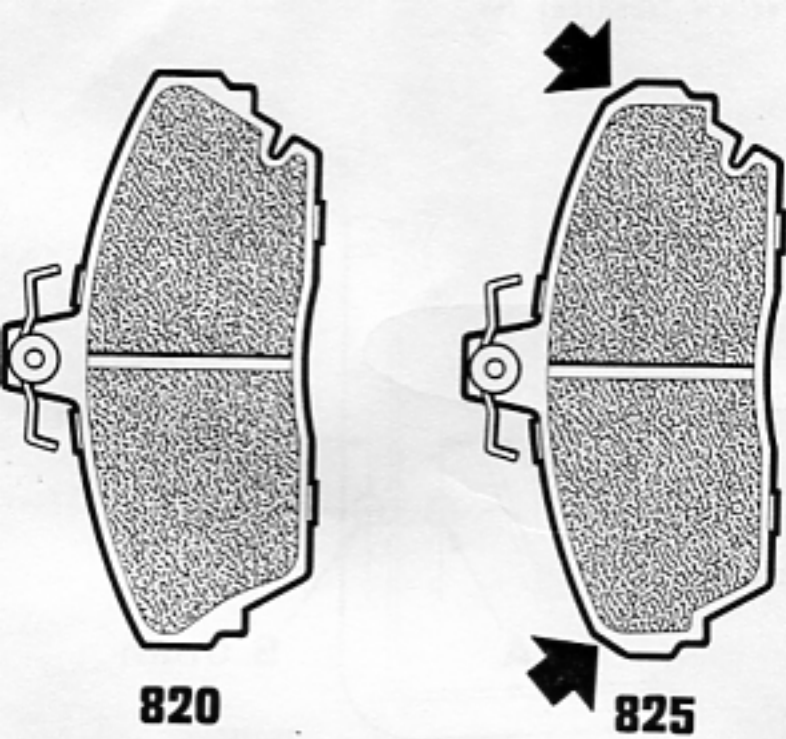
fig. 973/1

Problem: Knock or rattle from front suspension, heard when traversing sharp bumps or potholes.

Action: Should this noise be eliminated by driving car with foot brake applied, it is possible that one or more pads for a Rover 820 have been fitted inadvertently. The 820 pads have a backing plate which is slightly shorter than that for the 825, and hence the pad has unwanted vertical free play.

The two types of pad may be distinguished by the different shape of their lining as shown, and by the colour of the paint marking on the back plate tag, arrowed. For the 825, this marking should be either grey or red or yellow in colour.

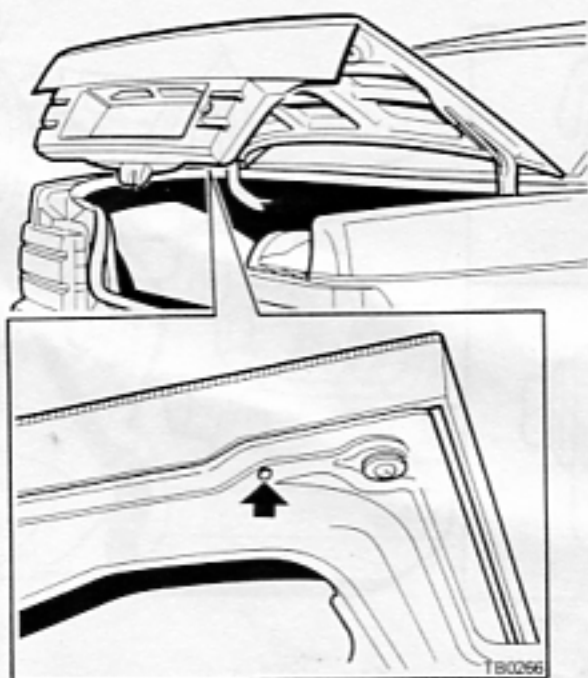
fig. 974/1

Problem: Water filling space between inner and outer skins of boot lid and thence running into luggage compartment when lid is opened.

Action: Drain holes should be drilled as described below:

- a. open luggage boot and cover bodywork and interior of boot to protect from drilling swarf.
- b. make centre punch mark at two points, one each side, where indicated in illustration, such that edge of 4 mm diameter hole will be close to outer skin of boot.
- c. drill holes 4 mm diameter.
- d. remove any roughness from edge of holes and treat bare metal with zinc-rich primer followed by colour coat.

Treat affected area within boot lid with cavity wax.
