AUSTIN ROVER

BULLETIN
Maestro **TECHNICAL**

THROTTLE CABLE SEIZURE

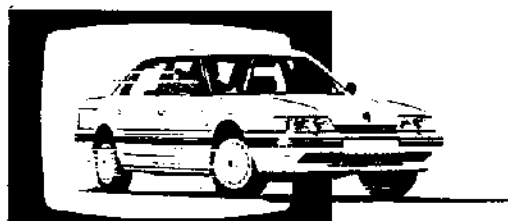
Premature wear of clutch centre plate.

Clutch release cable self adjusting mechanism not operating correctly

New clutch cables have been introduced on production and are available from Unipart. They should be fitted to earlier vehicles in the event of premature clutch wear. For fitting instructions, refer to the appropriate repair manual. Part number and change point details are as follows:
