AUSTIN ROVER

BULLETIN
MAESTRO TECHNICAL

Item 9

COOLANT LEAK FROM RADIATOR
 (Issue 2 to correct part nos.)

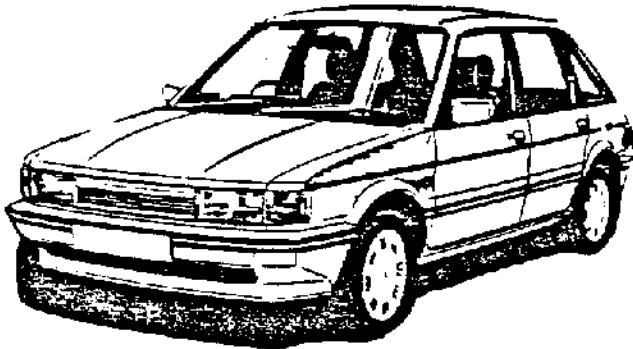
Coolant leaking from radiator.

Radiator damaged by engine vibration transmitted via excessively rigid top hose.

A modified hose can be identified as shown (see illustration) and, where this problem is encountered, one should be fitted at the same time as a replacement radiator to avoid recurrence.

More flexible top hose introduced at vin:

Maestro GRH 705 GRH 835

Maestro van GRH 714 GRH 836

Montego GRH 705 GRH 835
