**AUSTIN ROVER**

**BULLETIN**  
**MONTEGO TECHNICAL**

**Item 4**

**DOOR HINGE WELDS - INCOMPLETE**

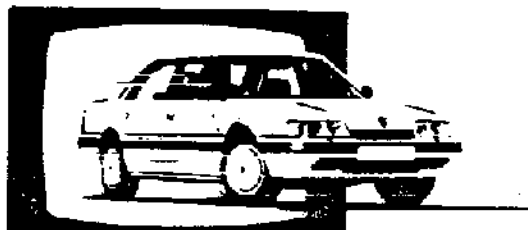
Welds between hinges and doors imperfect or incomplete.

Robot welder not operating correctly.

- 1 Examine welds (arrowed in illustration) between the hinges and the door on all four passenger doors (two doors only on van) and the door. Look for missing welds and for any weld in which the filler metal has not made a proper bond with the door panel.
- 2 Any missing or suspect weld should be dealt with as follows:
  - a. remove trim pad from door and disconnect wiring, where fitted.
  - b. remove door from car.
  - c. ensure that nothing within door will be damaged during welding.
  - d. use mechanical means, e.g. small rotary wire brush,

Examine welds as described below and re-weld as necessary.

to remove paint from area to be welded and make repair as necessary, using CO2 welding.

- e. clean off welded area, degrease and repaint using etch primer and normal repainting process. Treat similarly bare area on body where hinges are bolted and mating faces of hinges.
- f. treat inside of door where hinges are attached with Unipart cavity wax.
- g. refit door to car and adjust as necessary.
- h. make good paint damage to bolt heads.
- i. re-assemble door.
