AUSTIN ROVER

BULLETIN
MONTEGO TECHNICAL

Item 10

COOLANT LEAK FROM RADIATOR
 (Issue 2 to correct part nos.)

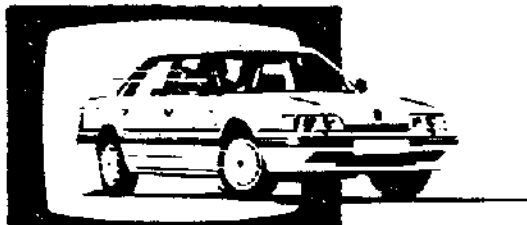
Coolant leaking from radiator.

Radiator damaged by engine vibration transmitted via excessively rigid top hose.

A modified hose can be identified as shown (see illustration) and, where this problem is encountered, one should be fitted at the same time as a replacement radiator to avoid recurrence.

More flexible top hose introduced at vin:

512224 Maestro

512234 Maestro van

422280 Montego

model	old part no.	new part no.
Maestro	GRH 705	GRH 835
Maestro van	GRH 714	GRH 838
Montego	GRH 705	GRH 835
